Mission Creek: Flood Risk Reduction and Streambank Restoration

by Jeremy Walgrave, PE & Nick Grewe

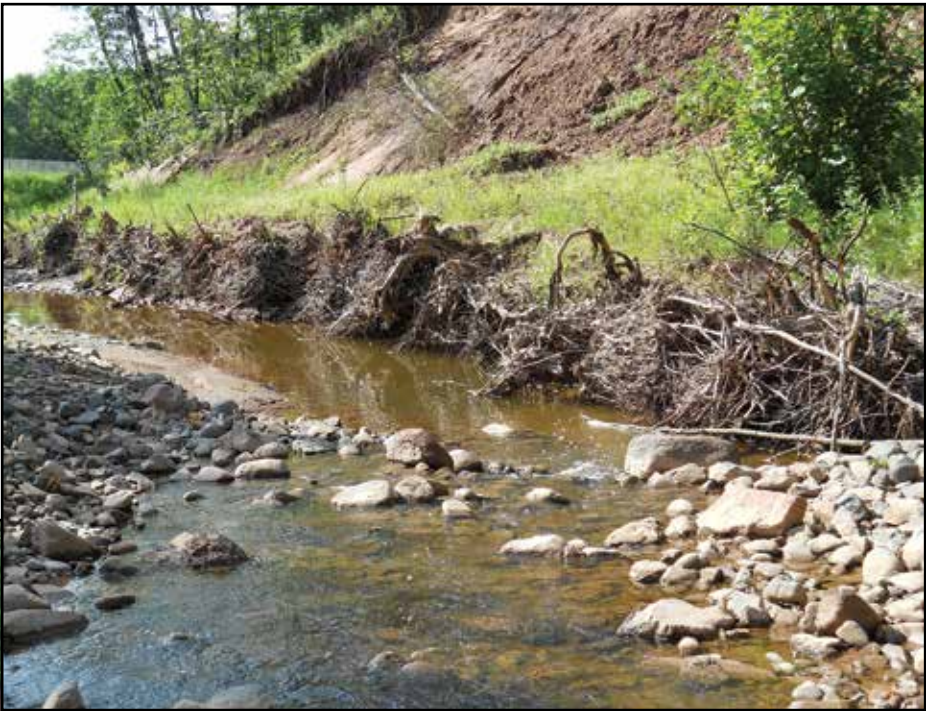
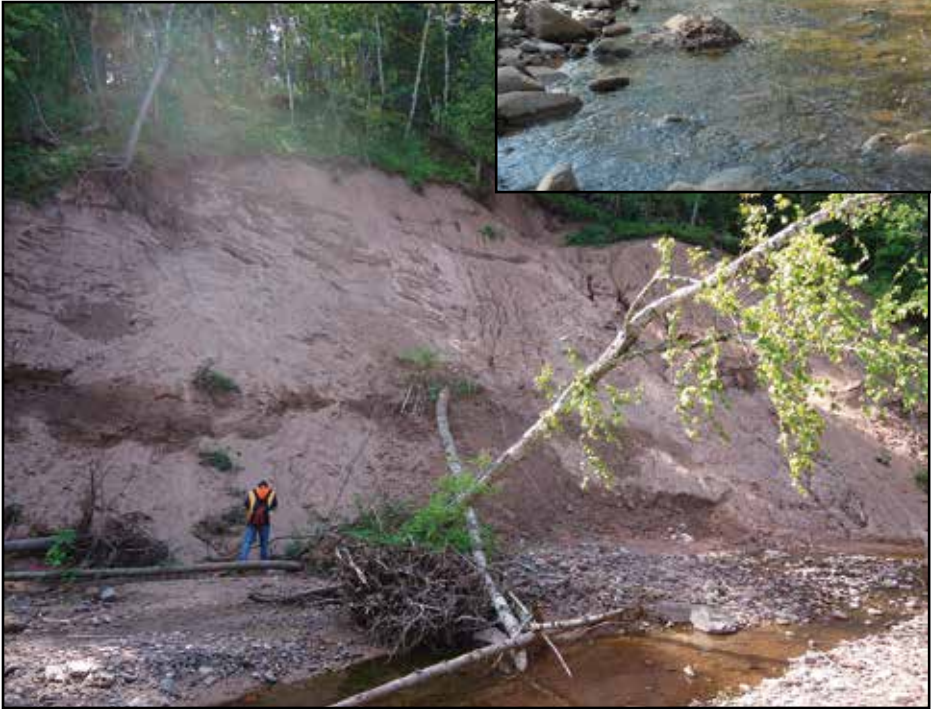
Left: Initial field survey in August, 2013. This slope failure is representative of others within the project boundary. Above: Same slope 1 year later; toe is stabilized with rootwads, live stakes, wattles, and native grass.

In order to stabilize the toe of large exposed slopes, a combination of rootwads, wattles, and live stakes were used. Root-

wads are large trees with their rootballs still intact. Typically, trunks are driven into the slope with the rootwad pointing upstream so that flow velocity vectors are broken up and scattered in all directions, thus decreasing the energy hitting the bank and greatly reducing erosion. Rootwads also provide resting and refuge areas for fish and other small critters. At Mission Creek, the contractors were unable to drive the root-

wads into the bank due to the presence of random boulders and rocks. Therefore, rootwads had to be laid out at the toe of failed slopes and then covered with excess material on site. This created a floodplain bench, which helped strengthen the toe and dissipate energy during larger flows in the creek. Due to the abundant number of felled trees onsite, all of the rootwads for the project were obtained from the site.

In addition to the rootwads, two rows of wattles and a mix of willow and red osier dogwood live stakes were used to fill in the gaps and naturally reinforce the floodplain benches.

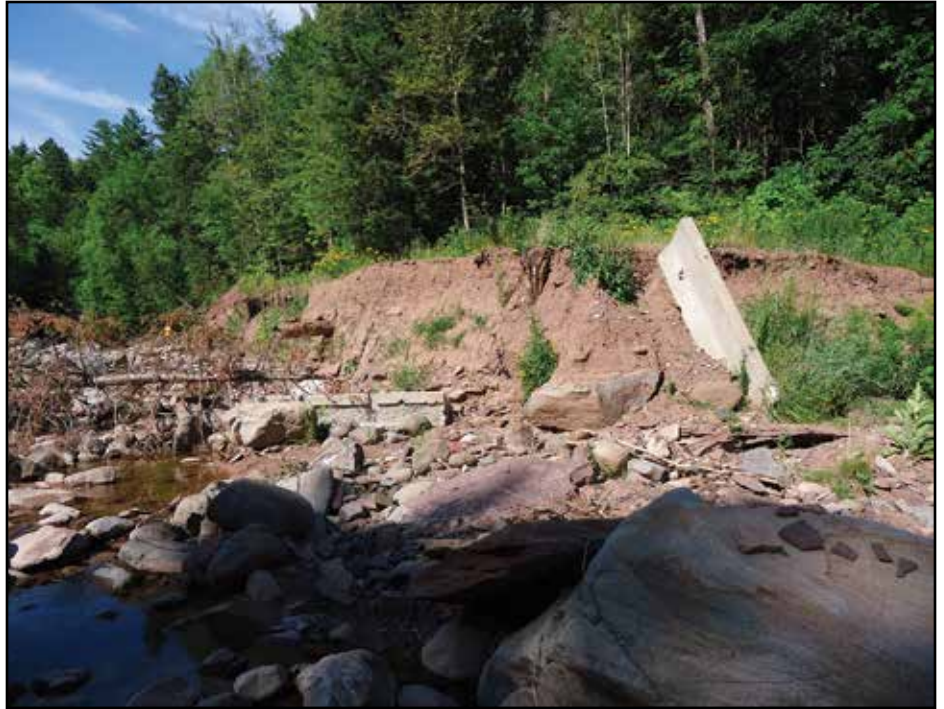
Above: This site is located at the upstream end of the project boundary. Note the concrete barriers embedded in the bank and channel bottom. Below: A bank that was stabilized by recreating a 3:1 slope and planting live stakes and native grass.
